UNIVERSITY OF ILLINOIS URBANA-CHAMPAIGN GREENHOUSE MASTER PLAN

June 2026

Existing Inventory

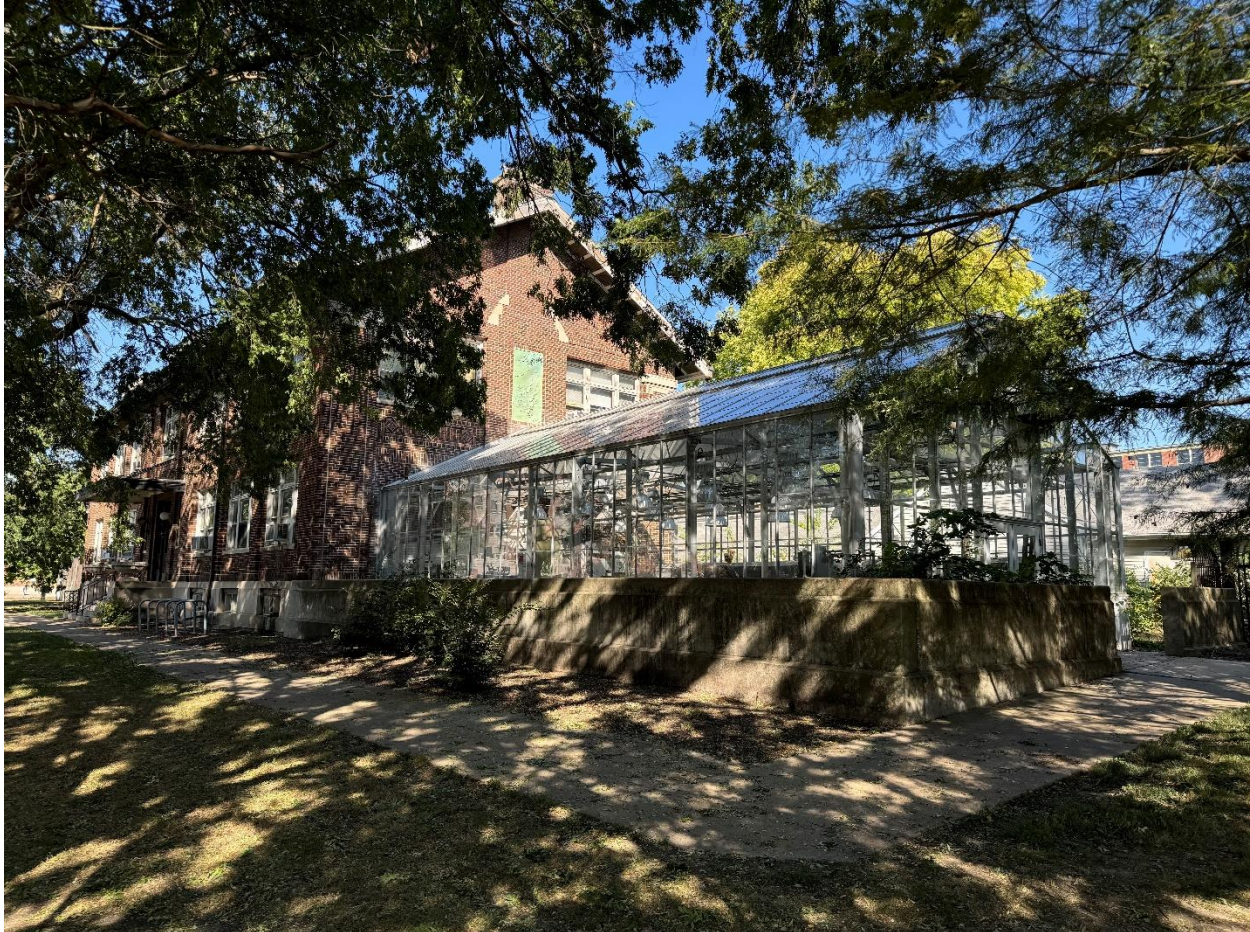
Shelford Vivarium Greenhouse

This facility was built in 1916 and houses plant research labs, aquatic research labs, storage, greenhouse, and vivarium.

1. Roof side wall height: 13'-2" verify
2. Floor Area: 1,277 NASF
3. Glazing: Single pane glass, good condition
4. Structure: Aluminum, fair condition
5. Floor: Concrete, fair condition
6. Climate Controls: Wadsworth, fair condition
7. Heating: Fin tube radiant perimeter heat, poor condition
8. Cooling: Ridge vent, exhaust fans, and evaporative coolers, fair condition
9. Humidity: None

10. Lighting: HID, good condition
11. Irrigation: Manual
12. Site drainage and runoff ponds: Good
13. Equipment: Sink

Ongoing Issues: Building is in very poor condition, lacks an elevator and has many accessibility deficiencies, and has a very large deferred maintenance backlog, including heating and cooling systems, building envelope problems, antiquated restrooms and plumbing systems, and other issues. The building, due to the extreme amount of deferred maintenance, is recommended to be decommissioned and the research relocated to alternate facilities.

Recommendations: Relocate research and demolish building.

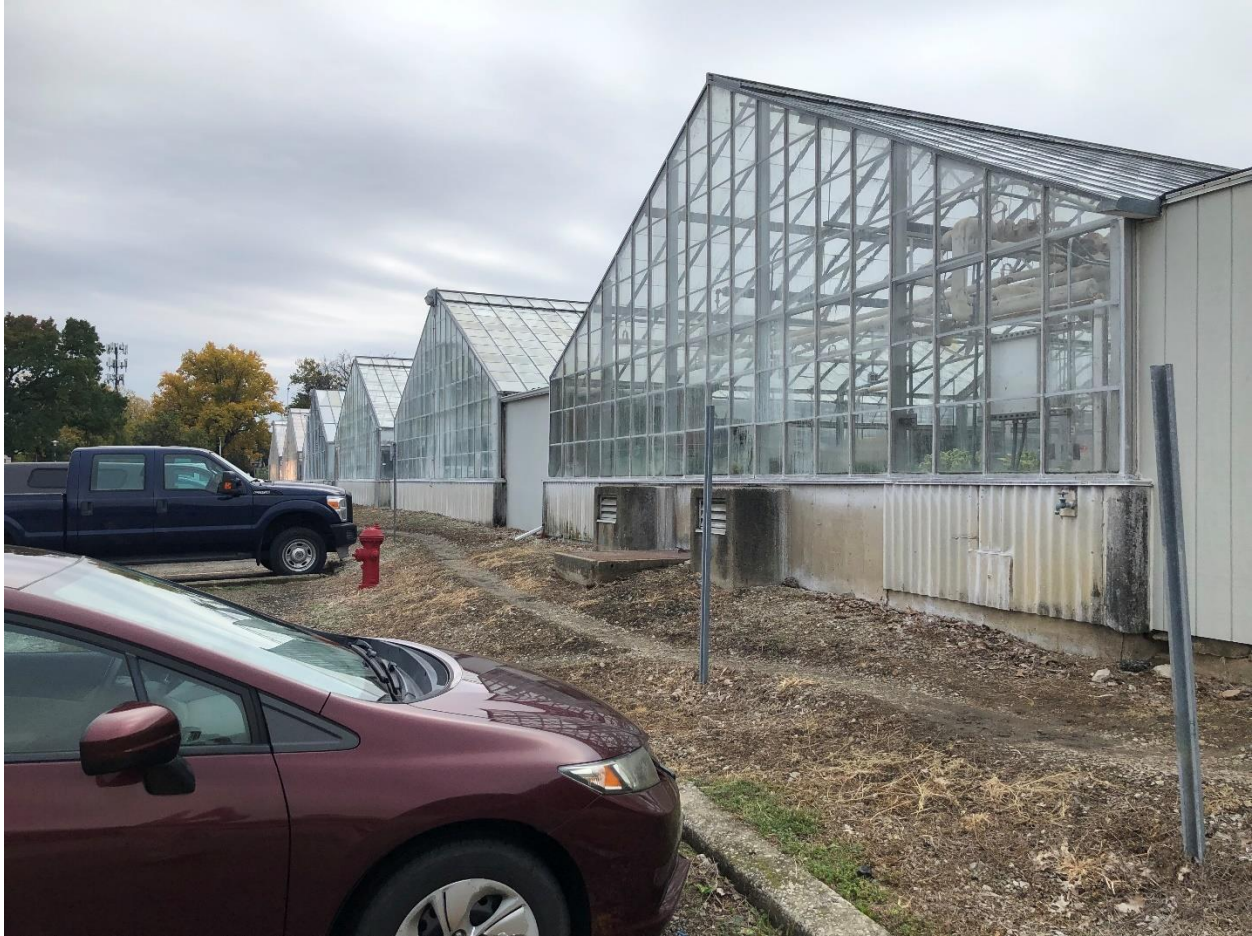
Turner Hall Greenhouses

This is the largest greenhouse on campus. It is in the ACES campus conveniently located near Turner Hall and other ACES buildings. Turner Greenhouses supports research projects from ACES, NRES, and IGB, class labs, along with extension and RSO projects. Turner Greenhouses hosts the Crop Sciences plant collections and the USDA Corn Germplasm collection. Many of the rooms are used for unregulated projects, but the newer southwest addition can hold up to biohazard level two projects in air-conditioned spaces. The wide walkways in these greenhouses are helpful for tours and class labs.

1. Roof side wall height: 11'-0" verify
2. Floor Area: 55,660 NASF
3. Glazing: Single pane glass, poor condition
4. Structure: Aluminum, good condition
5. Floor: Concrete, fair condition
6. Climate Controls: Vary. Titan 2007, fair condition, Argus, excellent condition.
7. Heating: Fin tube radiant perimeter heat and unit heaters, poor condition
8. Cooling: Evaporative coolers, ridge and side vents and exhaust fans, poor condition
9. Humidity: no active humidity controls
10. Lighting: HID, fair condition, LEDs, good condition
11. Irrigation: manual, poor. No water treatment so pH varies seasonally.
12. Site drainage and runoff ponds: Good

Ongoing Issues: The building is aged and needs significant capital investment to repair and renovate it. It is the largest greenhouse on campus and is a critical facility for much of campus' agricultural research. It's location near the heart of the ACES campus makes it impractical to replace with a new facility elsewhere on campus. Expansion of the facility is also desired to address space constraints that hamper ever-growing faculty and research requests.

Recommendations: Renovate and construct new addition.

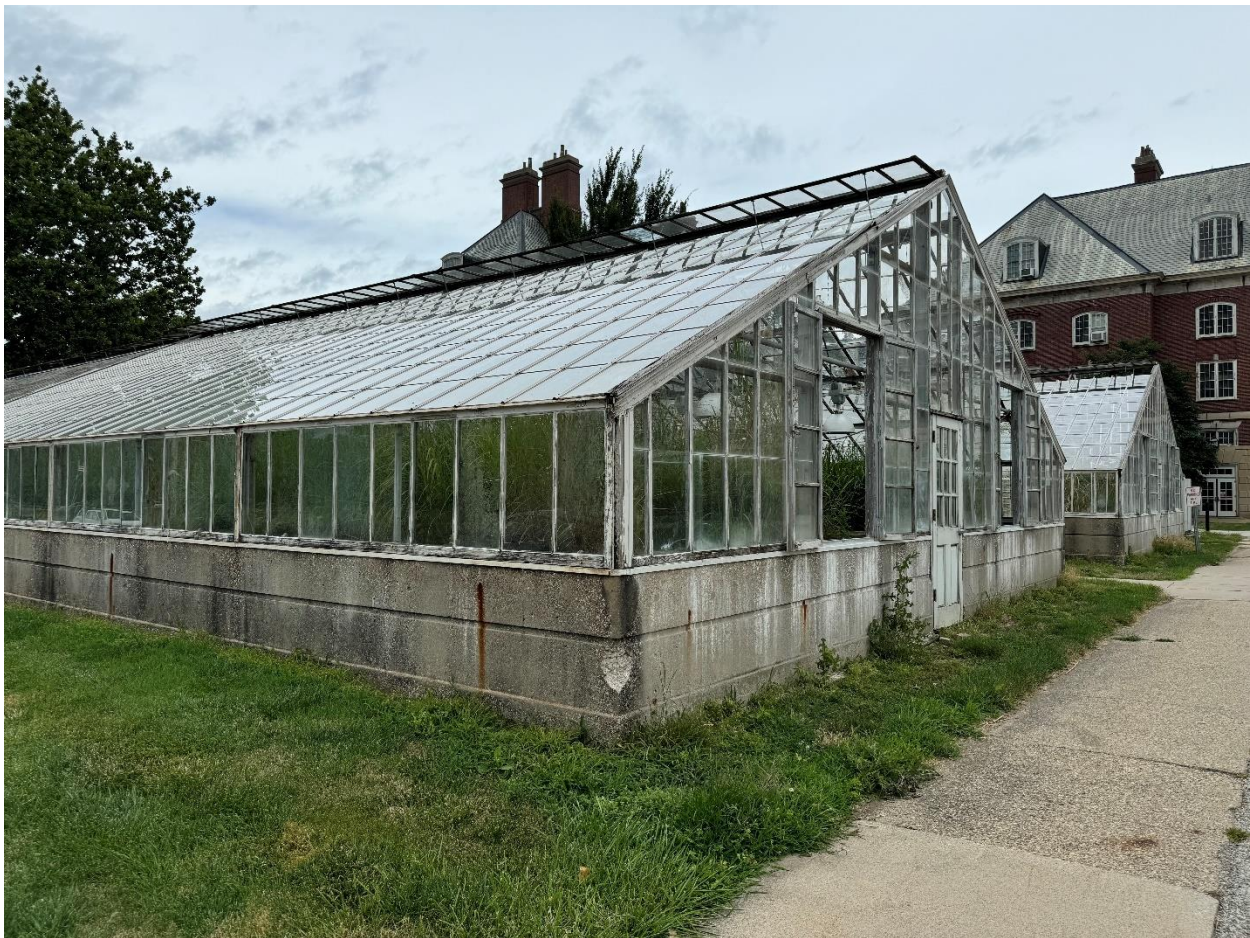
Natural History Survey Greenhouse

This 1940's greenhouse serves to house Miscanthus germplasm and propagation. It has been identified by F&S as a maintenance problem.

1. Roof side wall height: 6'-0"
2. Floor Area: 9,307 NASF

3. Glazing: Single pane glass, poor condition
4. Structure: Wood framing, poor condition
5. Floor: Concrete, fair condition
6. Side walls: Concrete, fair condition
7. Climate Controls: Individual pneumatic thermostats, fair condition
8. Heating: perimeter and under-bench steam heat pipes (bare, no fins), poor condition
9. Cooling: Ridge vents (manual) and unit coolers, poor condition
10. Humidity: None
11. Lighting: HID (rooms 4 and 7 only), fair condition
12. Irrigation: automated drip and sprinkler system built by end-users
13. Site drainage and runoff ponds: None
14. Equipment: Sink

Ongoing Issues: Building is in very poor condition, lacks accessibility, and is in a part of campus that is identified for redevelopment.

Recommendations: Relocate research and demolish building.

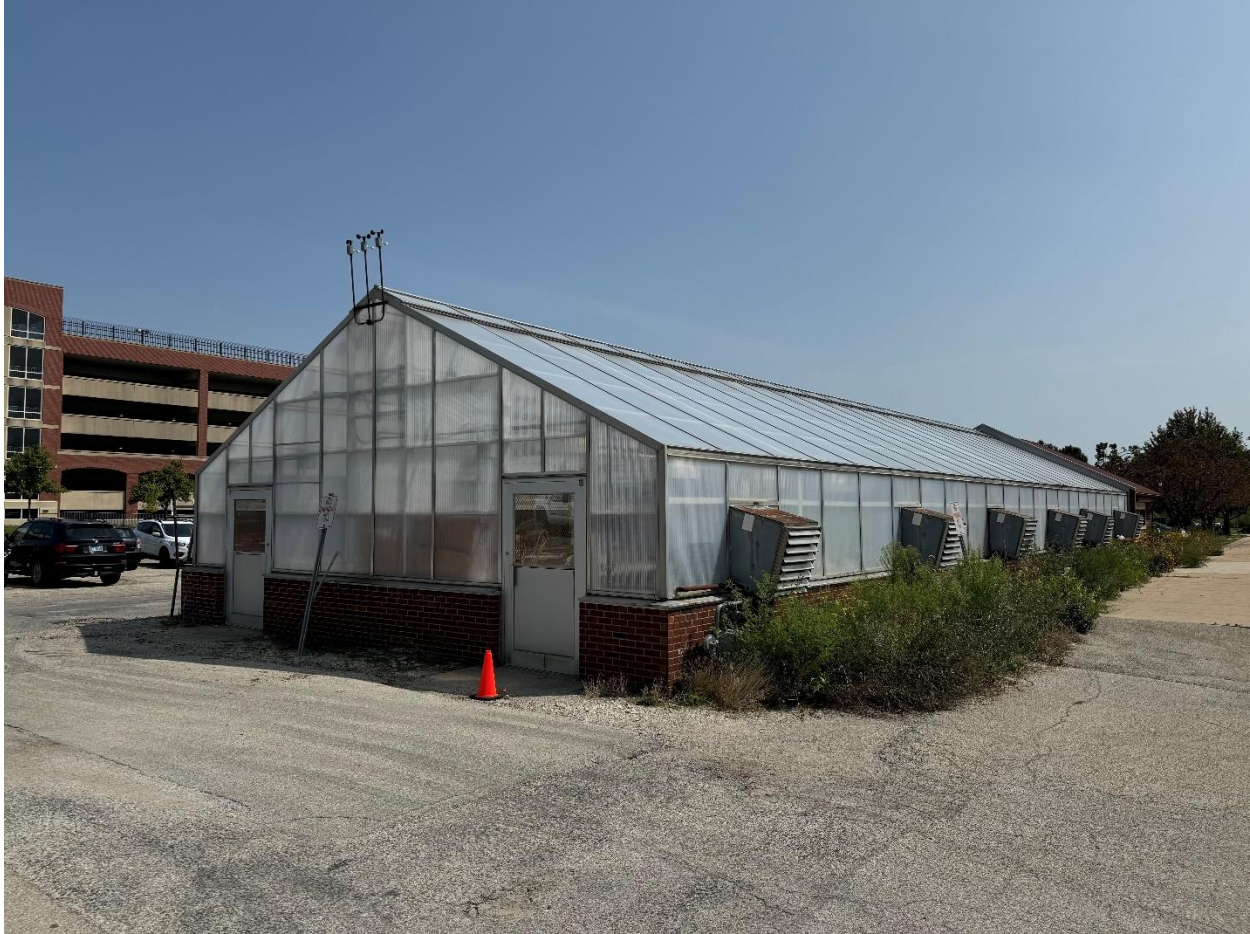
Located north of the Plant Sciences Laboratory, the USDA Nematology Greenhouse was built in 1972, and is used for research affiliated with the Realizing Improved Photosynthetic Efficiency (RIPE) project.

1. Roof side wall height: 8'-0" +/-
2. Floor Area: 2,876 NASF
3. Glazing: Single pane glass, fair condition
4. Structure: Aluminum, fair condition
5. Floor: Concrete, fair condition
6. Climate Controls: Wadsworth
7. Heating: Gas unit heaters, poor condition
8. Cooling: Evaporative cooling pads, ridge vent and exhaust fans, fair condition
9. Humidity: Aqua-Fogger
10. Lighting: HID, fair condition, LEDs, good condition
11. Irrigation: Manual
12. Site drainage and runoff ponds: Good
13. Equipment: One Conviron Gen2000 growth chamber

Ongoing Issues: Building is in fair to poor overall condition, including deteriorated masonry side walls, aging roof at head house, aged glazing, and low sidewall height. It is also located where a Plant Sciences

Lab addition is recommended. Note that access to the building

Recommendations: Maintain building until expansion of Plant Sciences Lab is funded. Relocate research and demolish building.

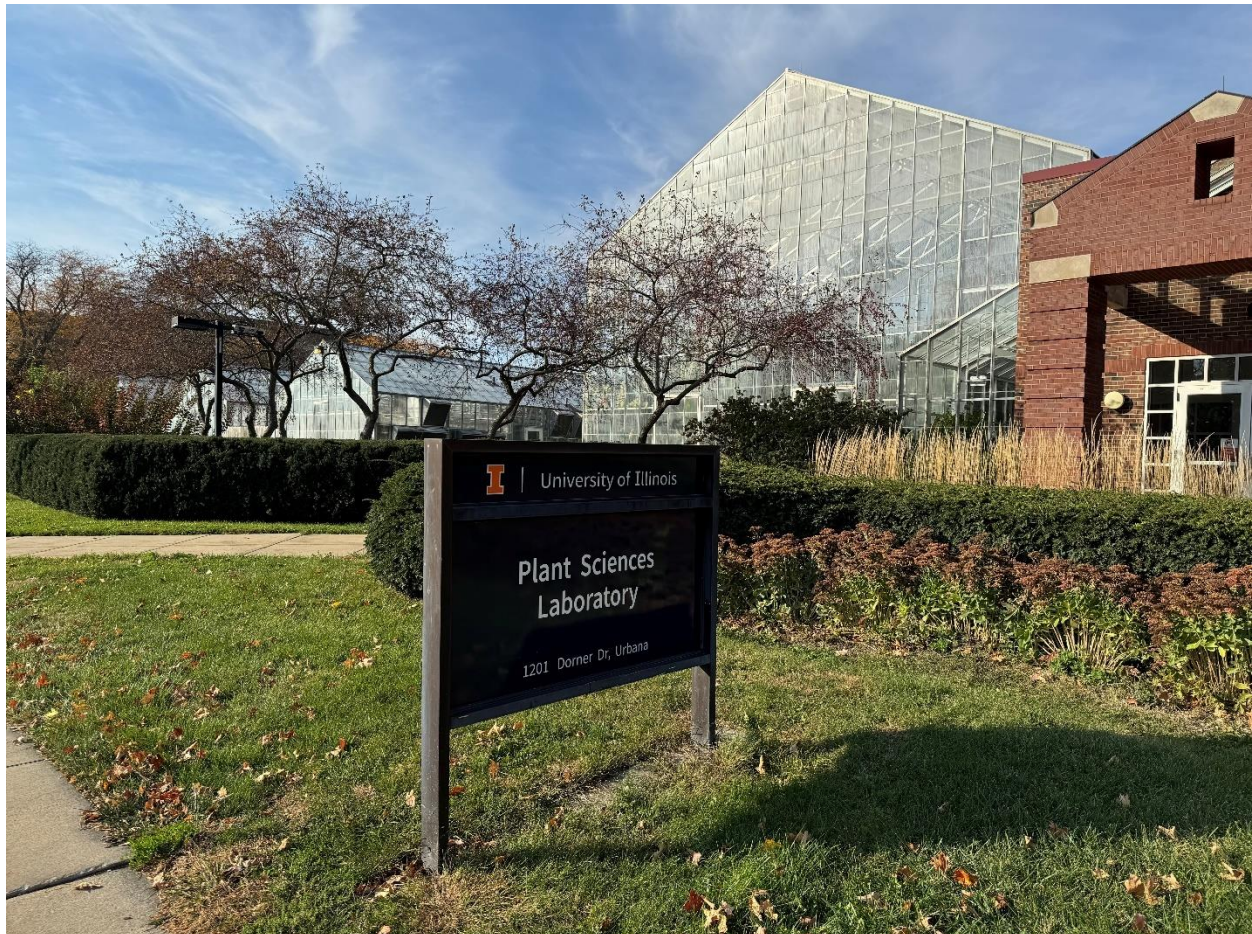
Plant Sciences Laboratory

This is the second largest greenhouse on campus. It is conveniently located at the edge of the main ACES campus and provides research greenhouse space for various labs mainly from the Colleges of ACES and College of LAS. PSL Greenhouse rooms can host Biohazard level one material and there are several air-conditioned rooms that support pathogen and insect research. PSL Greenhouses have an outstanding botanical plants collection and Conservatory on the northeast side of PSL Greenhouses along with a custom soil shop and storeroom that supports researchers onsite and the surrounding campus area.

1. Roof side wall height: 11'-0" verify
2. Floor Area: 51,759 NASF
3. Glazing: Single pane glass, poor condition
4. Structure: Aluminum, fair condition
5. Floor: Concrete, fair condition

6. Climate Controls: Argus, excellent condition
7. Heating: Fin tube radiant perimeter heat and unit heaters, fair condition
8. Cooling: Evaporative coolers, ridge and side vents and exhaust fans, fair condition
9. Humidity: No active humidity controls.
10. Lighting: HID, fair condition, LEDs, good condition
11. Irrigation: Automatic and manual. Acid injections and water softener system onsite for water treatment.
12. Site drainage and runoff ponds: Poor
13. Equipment: Growth chambers, coolers, grinder, autoclave, RO system, acid injector, four soil ground bed greenhouse rooms, storeroom and shop. Chemical mixing room, root washing room and nematology lab.

Ongoing Issues: The building is aged and needs significant capital investment to repair and renovate it. It is the second largest greenhouse on campus and is a critical facility for much of campus' agricultural research. It's location near the heart of the ACES campus makes it impractical to replace with a new facility elsewhere on campus. Expansion of the facility is also desired to address space constraints that hamper ever-growing faculty and research requests.

Recommendations: Renovate and construct new additions.

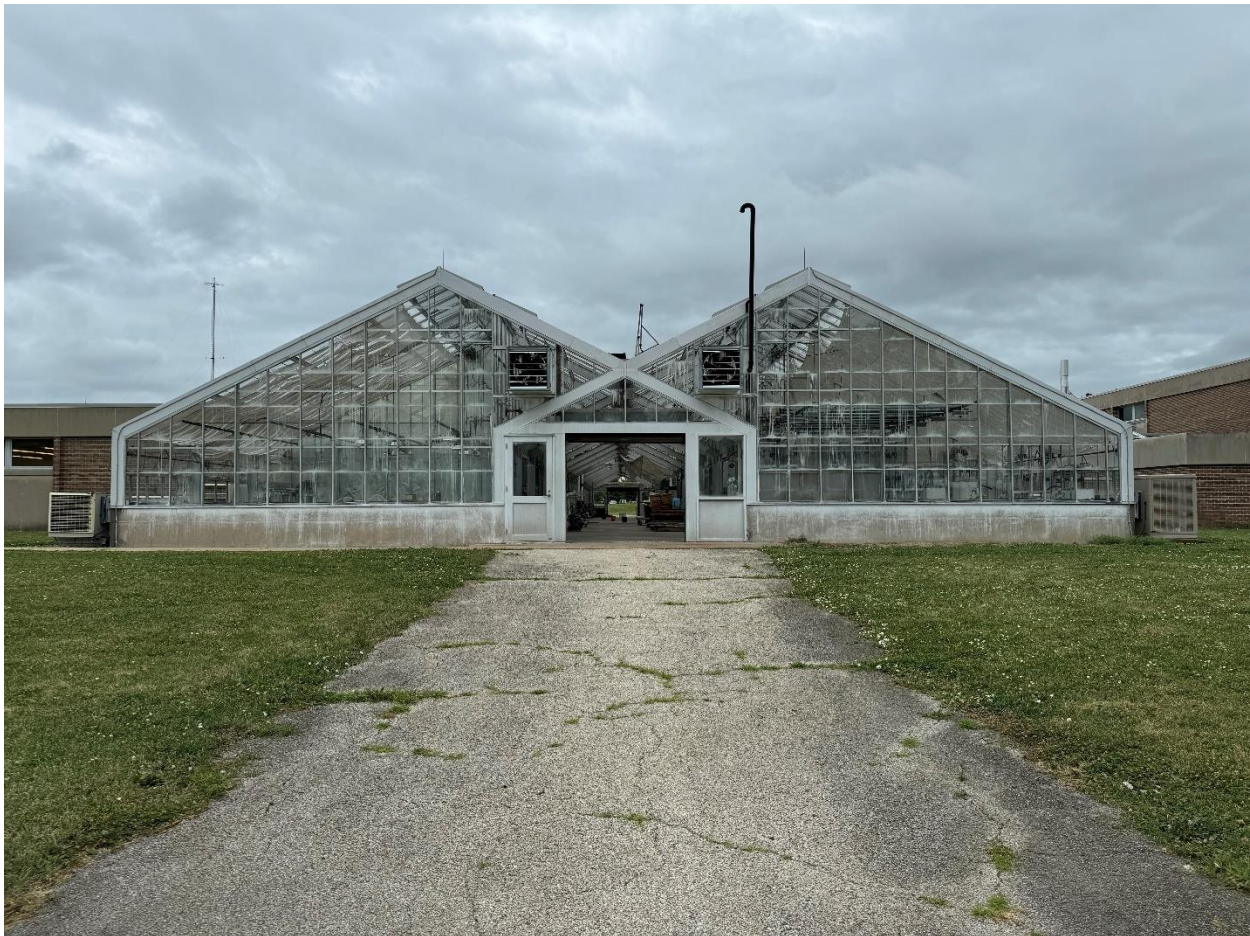
Natural Resources Studies Annex

This building houses laboratories and greenhouse spaces for the Illinois Natural History Survey. It is in

1. Roof side wall height: 8'-0"
2. Floor Area: 11,558 NASF
3. Glazing: Single pane glass, poor condition
4. Structure: Aluminum
5. Floor: Concrete, fair condition, and soil
6. Climate Controls: Argus, poor condition
7. Heating: Fin tube radiant perimeter heat and unit heaters, poor condition
8. Cooling: Ridge vent, side vents and exhaust fans, fair condition
9. Humidity: None
10. Lighting: HID, fair to poor condition
11. Irrigation: manual
12. Site drainage and runoff ponds: None
13. Equipment: Sinks

Ongoing Issues: Building is in fair to poor condition and requires a significant investment to repair infrastructure including heating, cooling, controls, lighting, and glazing.

Recommendations: Renovate to meet current standards and needs.

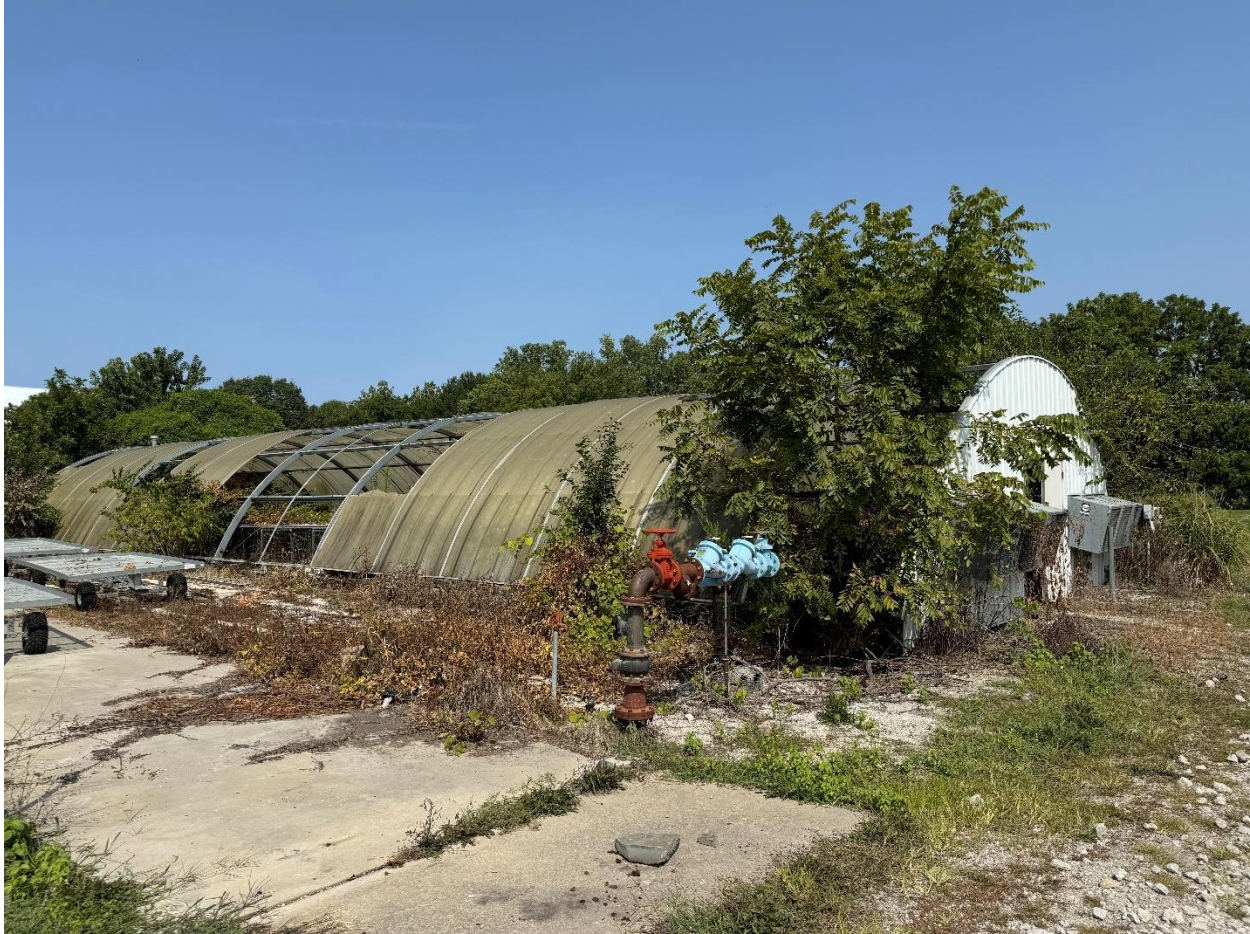
Woody Ornamentals Greenhouse

This small greenhouse, built in 1982, served Crop Sciences until it was damaged by a storm. There are discussions and plans to relocate components of the Sustainable Student Farm to this location to improve access and visibility. This location is closer to a campus bus route, allowing the expansion of educational offerings and serving better as an outward-facing educational space for the College of ACES. The existing concrete pad to the north is large enough to add several more hoop houses.

1. Roof side wall height: 8'-0"
2. Floor Area: 1,277 NASF
3. Glazing: Double wall acrylic, poor condition
4. Structure: Galvanized steel hoop, fair condition
5. Floor: Soil
6. Climate Controls: Sterling, unknown condition
7. Heating:
8. Cooling: Exhaust fans, unknown condition
9. Humidity: None
10. Lighting: None
11. Irrigation: manual
12. Site drainage and runoff ponds: Good
13. Equipment: None

Ongoing Issues: Building is in poor condition, but essential structure (galvanized steel hoop) remains in fair condition. It is in a part of campus that is identified for redevelopment which includes a new greenhouse structure.

Recommendations: Renovate to meet the needs of the redevelopment plan for relocating the sustainable student farm.

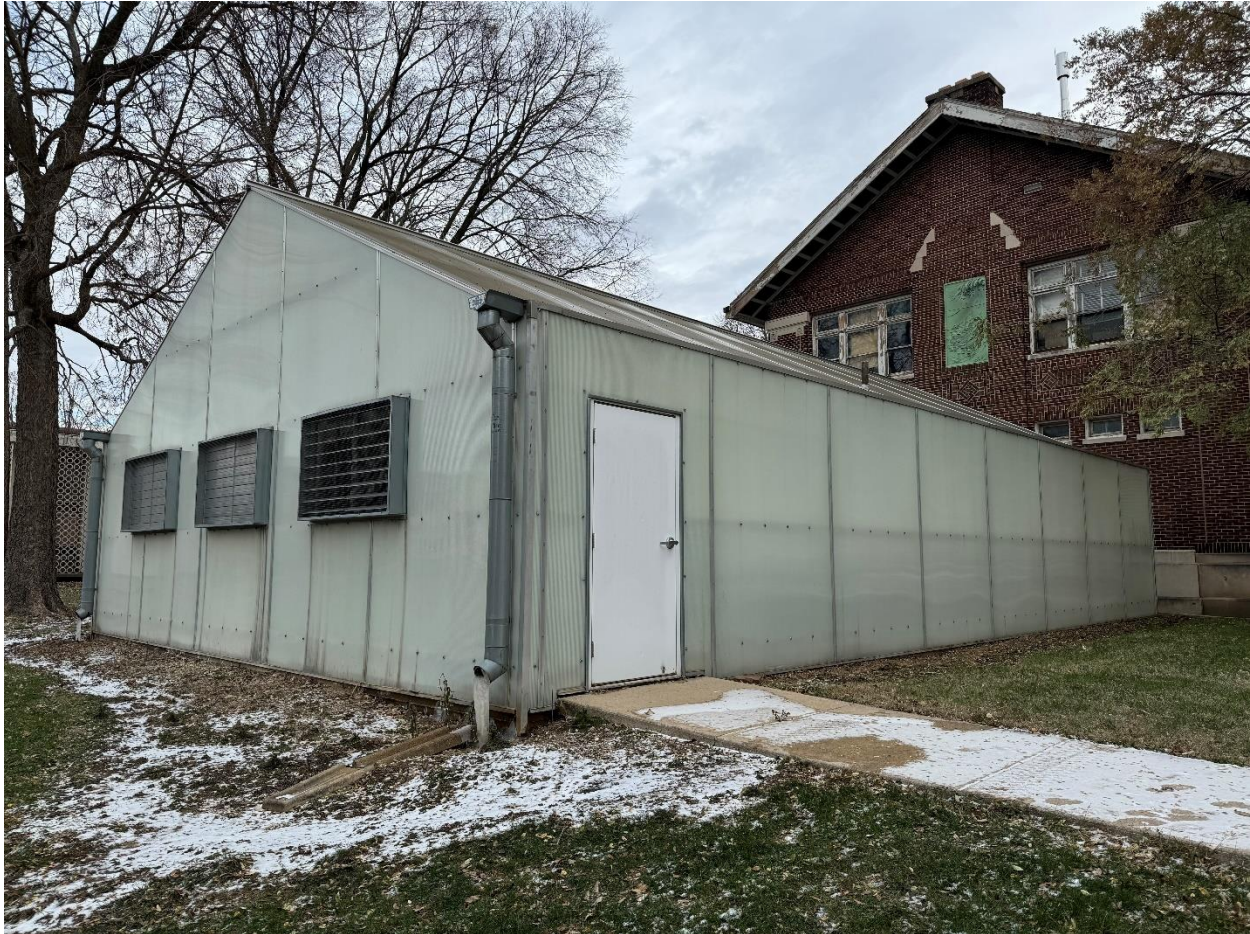
Shelford Vivarium Greenhouse

This facility was built in 2007 and houses aquatic research tanks.

1. Roof side wall height: 8'-6"
2. Floor Area: 1,401 NASF
3. Glazing: Double wall polycarbonate, translucent UV blocking, good condition
4. Structure: Galvanized steel, good condition
5. Floor: Concrete, good condition
6. Climate Controls: Micro-Grow, good condition
7. Heating: Unit heaters, good condition

8. Cooling: Exhaust fans, evaporative coolers, good condition
9. Humidity: None
10. Lighting: HID, good condition
11. Irrigation: Manual, water treatment tanks
12. Site drainage and runoff ponds: Good
13. Equipment:

Ongoing Issues: Building is in good condition, with only minor rusting issues at metal supports.

Recommendations: Maintain; relocate if deemed necessary for campus expansion.

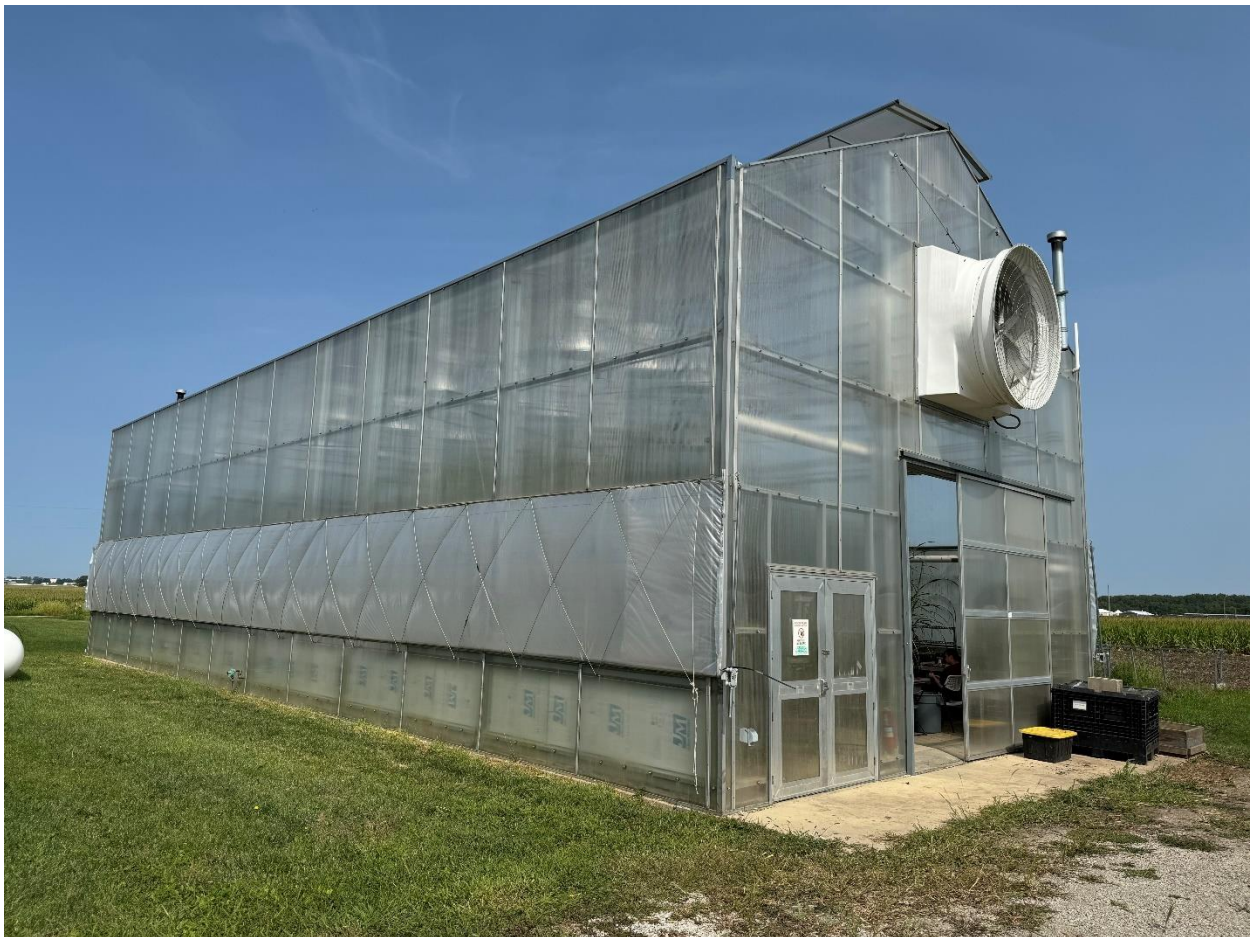
Energy Farm Greenhouse 1

These greenhouses were constructed in 2013 to support Crop Science research. While it does not have a head house, the nearby Energy Barn has a laboratory for use by researchers.

1. Roof side wall height: 20'-0"
2. Floor Area: 2,029 NASF
3. Glazing: Double wall polycarbonate, good condition
4. Structure: Galvanized Steel / Aluminum, good condition
5. Floor: Concrete, good condition

6. Climate Controls: Link4 , scheduled for upgrade to Wadsworth Seed controller Spring 2025
7. Heating: Hydronic Radiant floor / fin tube heating (biomass) and unit heaters (1 hydronic, 2 propane), good condition
8. Cooling: Ridge and side vents, 2 louvered intakes and 1 exhaust fan, good condition
9. Humidity: NONE
10. Lighting: HID, poor condition. Fixtures were not ideal for greenhouse and have increasing electrical failures.
11. Irrigation: Automatic
12. Site drainage and runoff ponds: Good
13. Equipment: None

Ongoing Issues: Link4 controller is not as reliable as needed for research greenhouse. Lights are reaching end of life and requiring increasing maintenance.

Recommendations: Maintain.

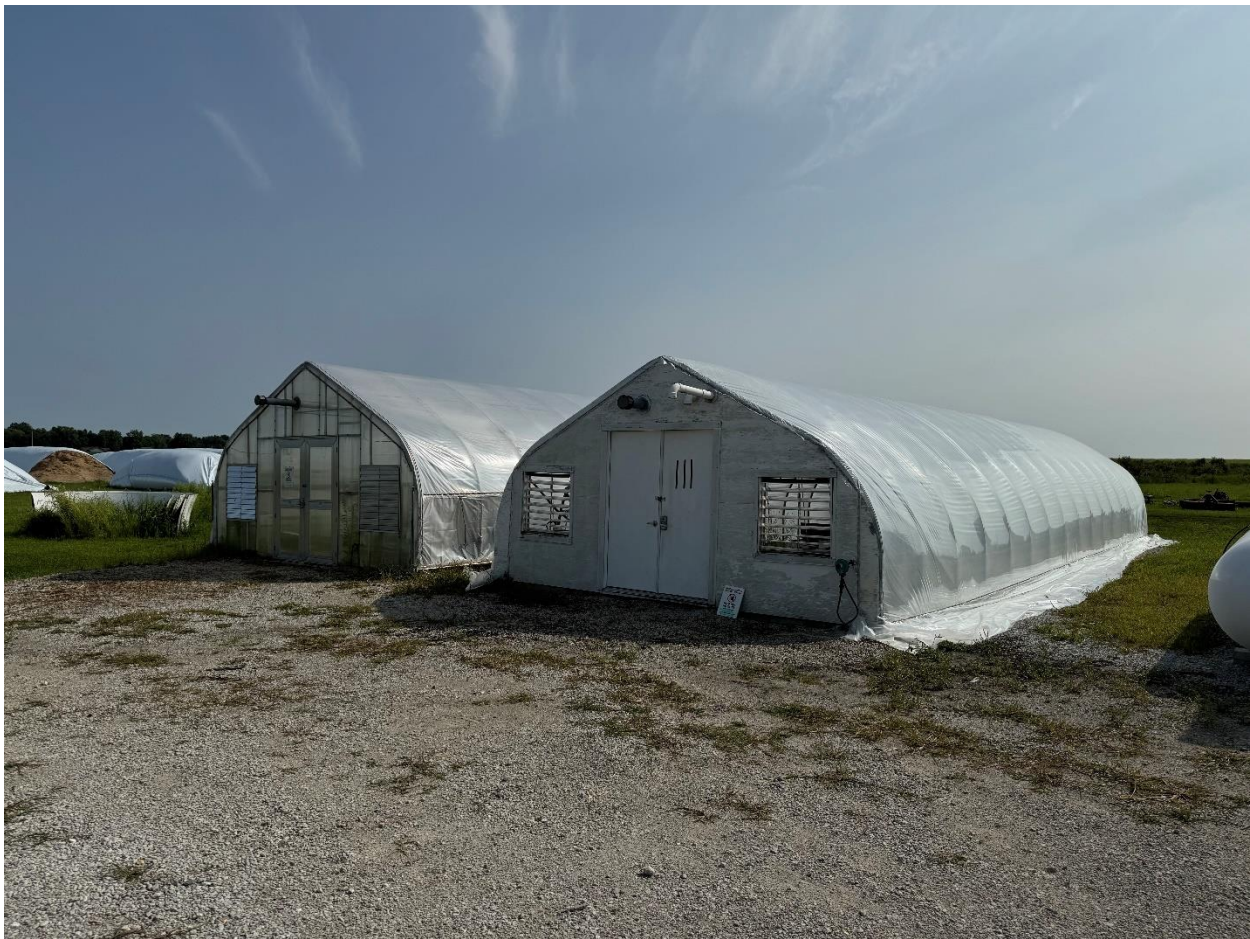
Energy Farm Greenhouses 2 and 3

These greenhouses were constructed between 2013 and 2021 to support Crop Science research. While they do not have head houses associated with them, there is a nearby building, the Energy Barn, which has a laboratory for use by researchers.

1. Roof side wall height: 8'-0"
2. Floor Area: 1,004 and 1,123 NASF
3. Glazing: Poly, good condition
4. Structure: Galvanized Hoop, good condition
5. Floor: Aggregate.
6. Climate Controls: Link4, fair condition scheduled for upgrade to Wadsworth Seed controller Spring 2025
7. Heating: Propane unit heaters, good condition
8. Cooling: Exhaust fans, good condition
9. Humidity: None
10. Lighting: None
11. Irrigation: automatic
12. Site drainage and runoff ponds: Good
13. Equipment: None

Ongoing Issues: Propane unit heaters are not adequate on lowest temperature nights of winter. Diesel fueled "Salamander" heaters are needed at peak heating. Ideal to add concrete floors with radiant floor heating supplied by nearby biomass boiler system. Future improvements include replacing the existing poly-film with semi-rigid plastic panels (e.g. polycarbonate) for reduced maintenance and greater durability.

Recommendations: Maintain.

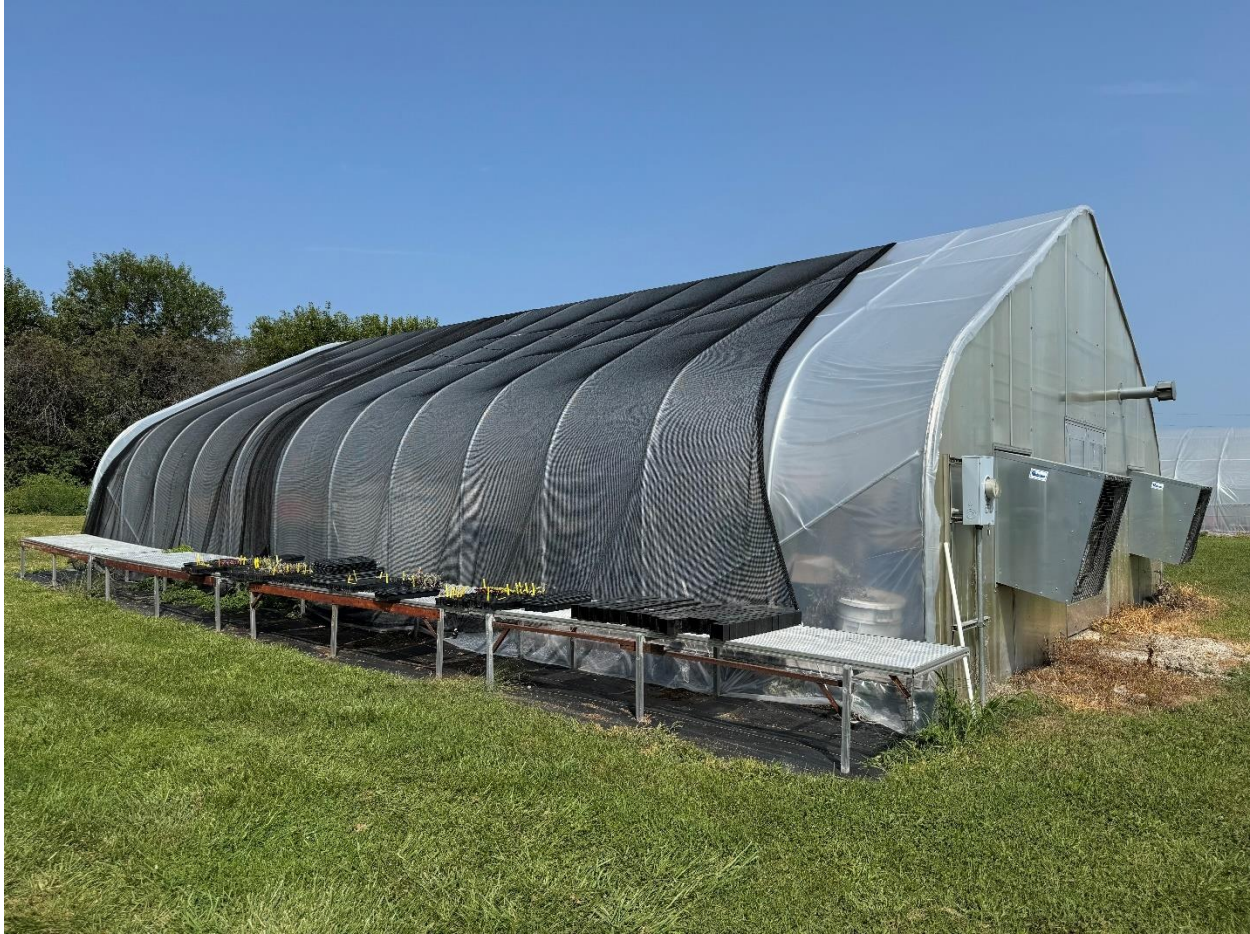
Fruit Research Farm Greenhouse #1

This small greenhouse, built in 2014, serves Crop Sciences...

1. Roof side wall height: 8'-0" +/-
2. Floor Area: 1,427 NASF
3. Glazing: Poly, good condition
4. Structure: Aluminum hoop house
5. Floor: Concrete, soil, good condition
6. Climate Controls: Thermostat, good condition
7. Heating: None
8. Cooling: Circulation and exhaust fans, good condition
9. Humidity: None
10. Lighting: limited HID, good condition
11. Irrigation: manual
12. Site drainage and runoff ponds: Good
13. Equipment: None

Ongoing Issues: None.

Recommendations: Maintain.

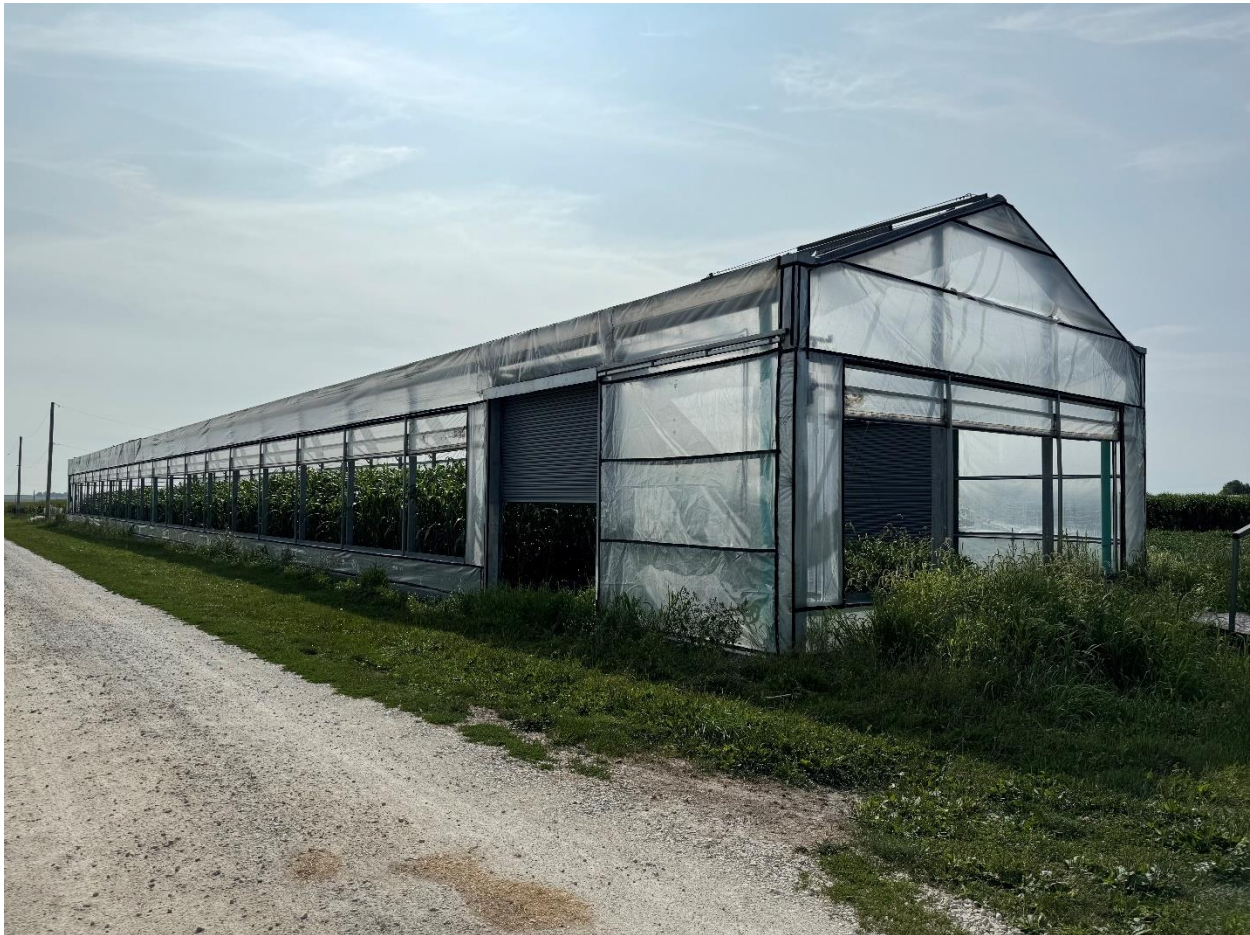
Retractable Roof Greenhouse

This medium sized greenhouse, built in 2021, serves Plant Biology, and is used to test drought resistance by reducing the amount of rain that reaches the crops below. This structure was the topic of much discussion regarding the facilities standards that were applied during construction. The overall impression was that the standards exceeded what was necessary for this type of structure.

1. Roof side wall height: 16'-0" +/-
2. Floor Area: 7,185 GSF
3. Glazing: Poly
4. Structure: Aluminum, excellent condition
5. Floor: Soil
6. Climate Controls: None
7. Heating: None
8. Cooling: None
9. Humidity: None
10. Lighting: none
11. Irrigation: None

Ongoing Issues: None.

Recommendations: Maintain.

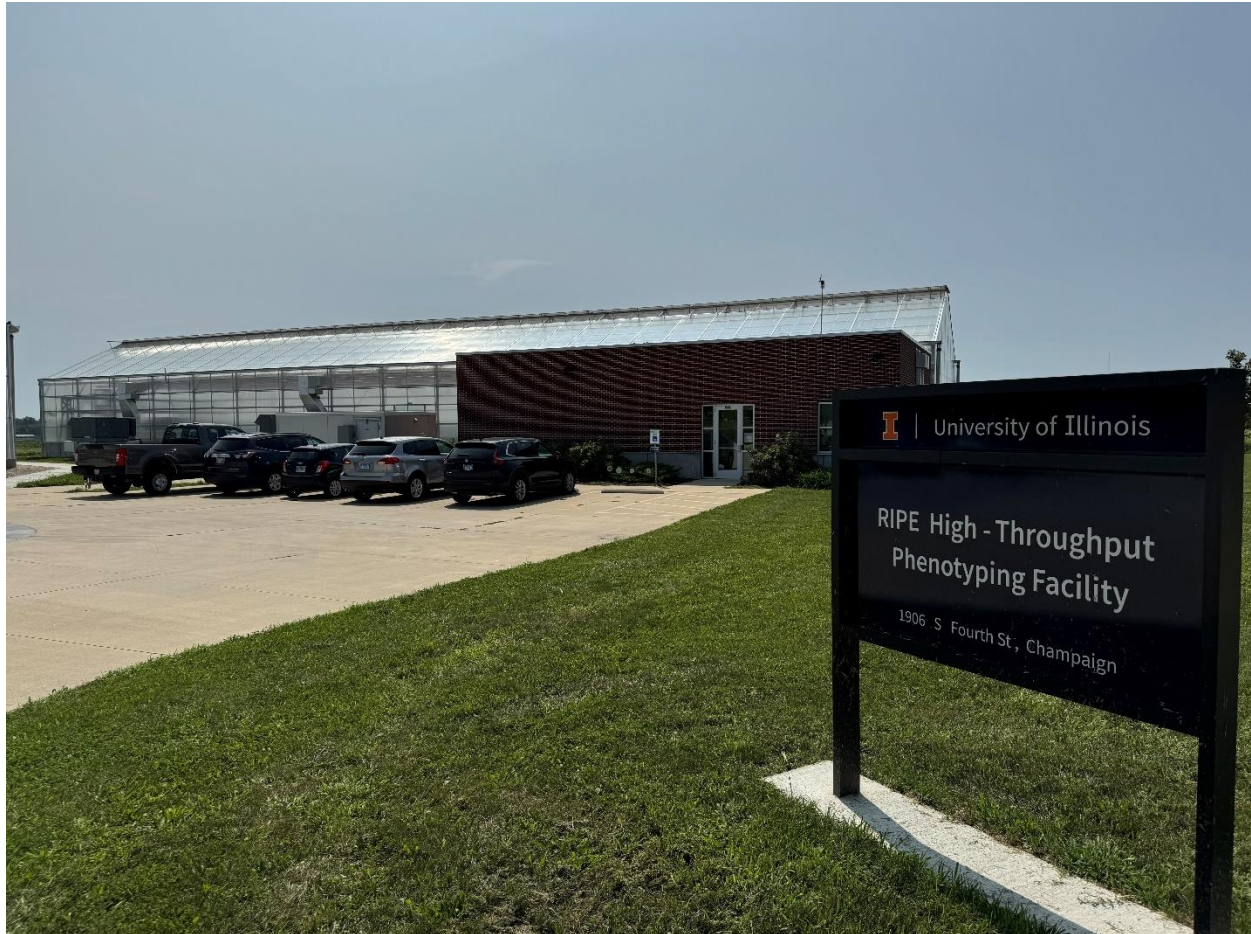
RIPE High-Throughput Phenotyping Facility

This new greenhouse, finished in 2020, is in the Research Park. It was developed to support Institute for Genomic Biology research. Heating and cooling in the facility is provided by geothermal heat exchangers.

1. Roof side wall height: 12'-0"
2. Floor Area: 7,813 NASF
3. Glazing: Double wall polycarbonate, excellent condition
4. Structure: Aluminum, excellent condition
5. Floor: Concrete, excellent condition
6. Climate Controls: Argus, excellent condition

7. Heating: Radiant floor heat, fin tube perimeter heat and unit heaters, excellent condition
8. Cooling: Evaporative coolers, ridge and side vents and exhaust fans, excellent condition
9. Humidity: Mistlers
10. Lighting: LED, excellent condition
11. Irrigation: automatic, including fertigation
12. Site drainage and runoff ponds: Excellent
1. Equipment: Rapid throughput phenotyping, growth chambers, RO water, cold room, grinder, autoclave, cameras, blackout curtains.

Ongoing Issues: None.

Recommendations: Maintain.

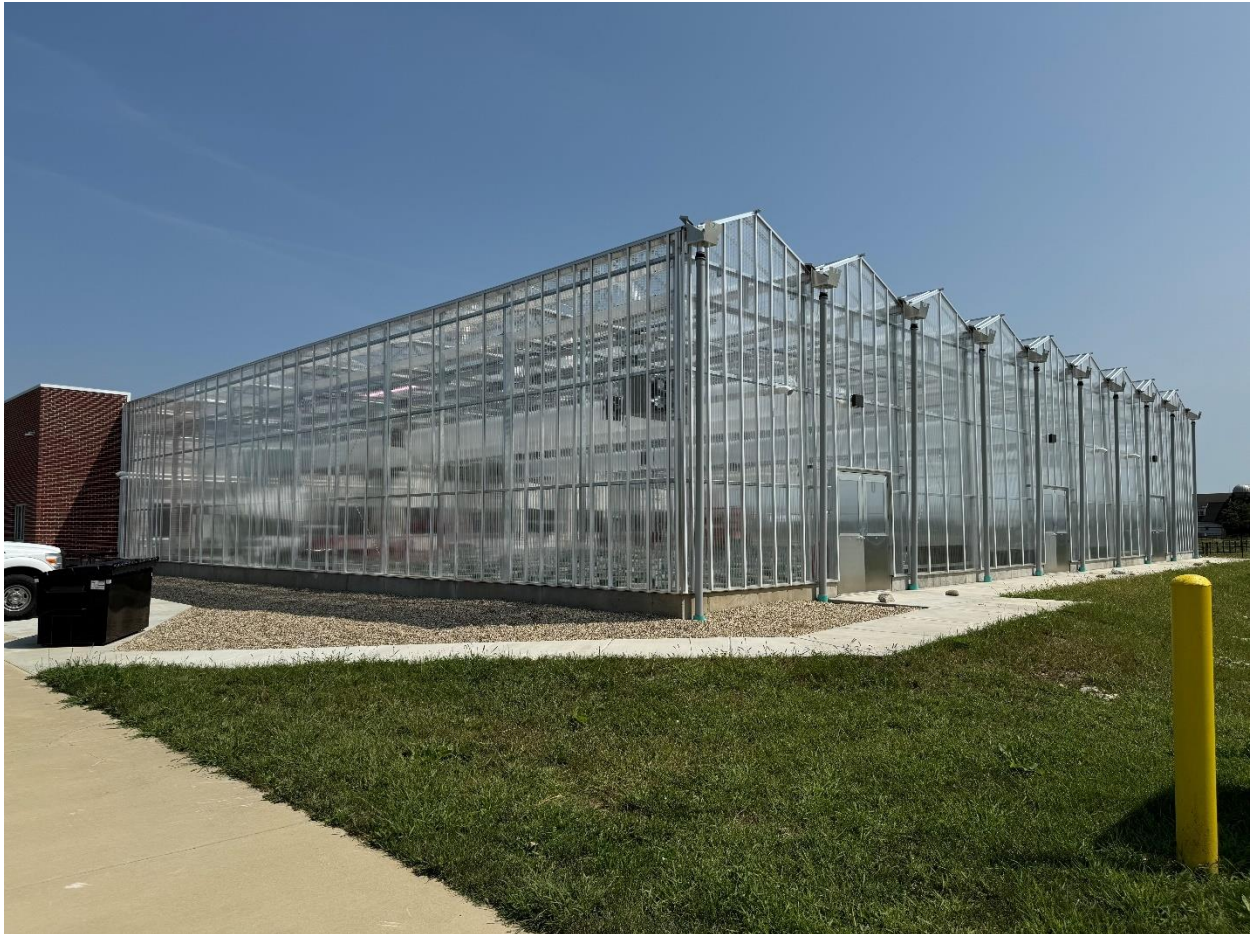
Plant Biology Innovation Greenhouse

The most recent addition to campus, this greenhouse serves CABBI. It includes a head house with eight growth chambers as well as a solar panel array.

2. Roof side wall height: 12'-0"

3. Floor Area: 14,192 NASF
4. Glazing: Double wall acrylic, excellent condition
5. Structure: Aluminum, excellent condition
6. Floor: Concrete, Excellent condition
7. Climate Controls: Argus, excellent condition
8. Heating: Radiant hydronic floor heat and unit heaters, excellent condition
9. Cooling: Evaporative cooling via unit coolers on roof of headhouse, ridge vent, exhaust fans, solar shades, excellent condition
10. Humidification: foggers
11. Lighting: LED, excellent condition
12. Irrigation: Automatic, including fertigation system
13. Site drainage and runoff ponds: Excellent
14. Equipment: Rapid throughput phenotyping, growth chambers, RO water, cold room, grinder, autoclave, photovoltaic system.

Ongoing Issues: Some water infiltration issues at roof vents have impacted phenotyping experiments and are being resolved with the contractor.

Recommendations: Maintain.

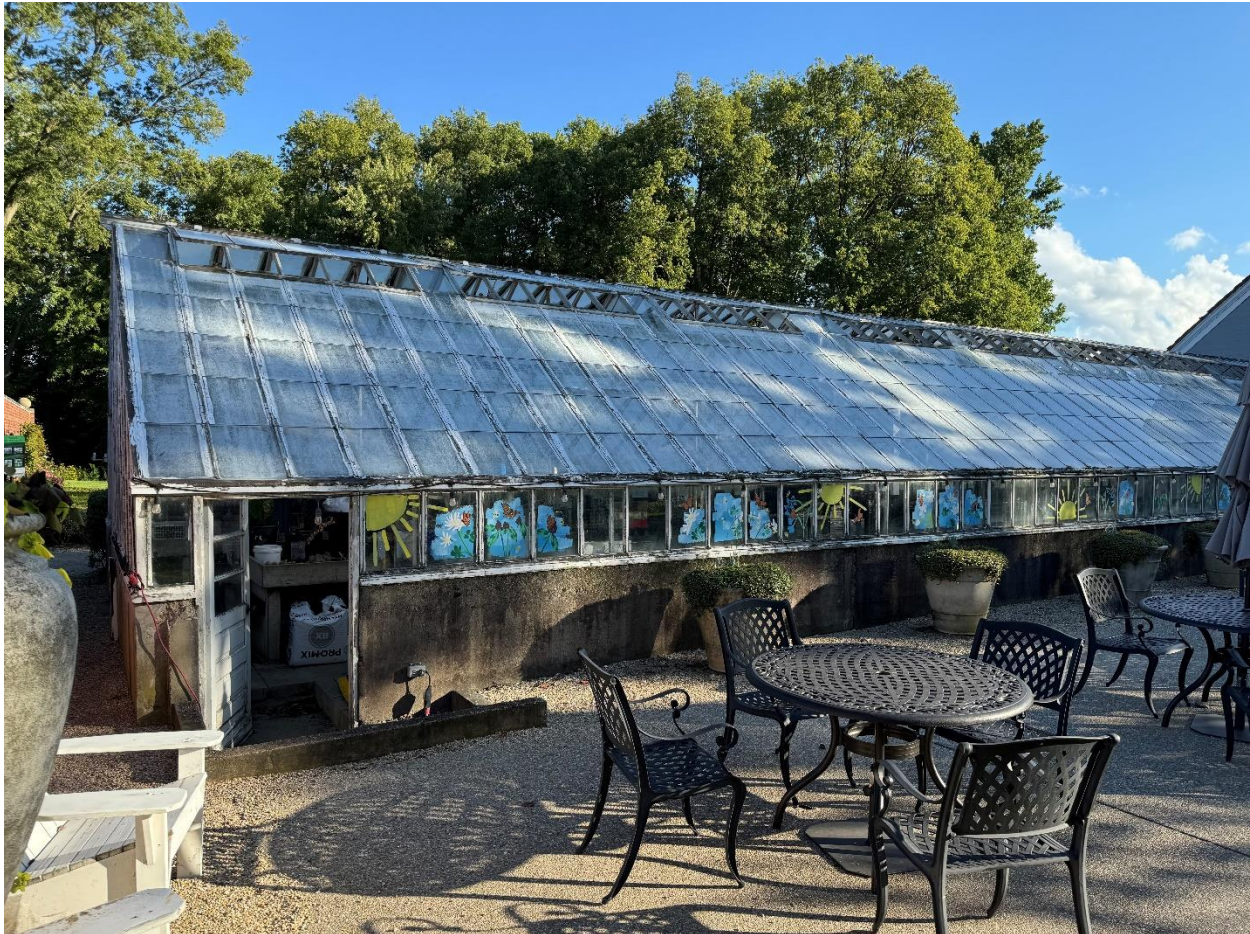
Allerton Visitor's Center – RAPCC

This small, historic production greenhouse is operated by Allerton Park. It is not a research facility and is supported by Allerton operational funds.

1. Roof side wall height: 8'-0"
2. Floor Area: 1,277 NASF
3. Glazing: Single pane glass, poor condition
4. Structure: Wood, poor condition
5. Floor: Concrete, fair condition
6. Climate Controls: Unknown
7. Heating: Fin tube radiant perimeter heat and unit heaters, poor condition
8. Cooling: Ridge vent and exhaust fans, fair condition
9. Humidity: None
10. Lighting: HID, fair condition
11. Irrigation: manual
12. Site drainage and runoff ponds: None
13. Equipment: Sink

Recommendations: Maintain.
